## North Coast Regional Water Quality Control Board

### **Inspection Report for September 18, 2019 Warrant Inspection, Humboldt County Assessor's Parcel Number 211-361-007-000**

File: Cannabis Program Inspections, Humboldt County, September 2019  
HCSO/Green Wave Humboldt County Inspections, Paul Thompson,  
CIWQS Place ID 861375

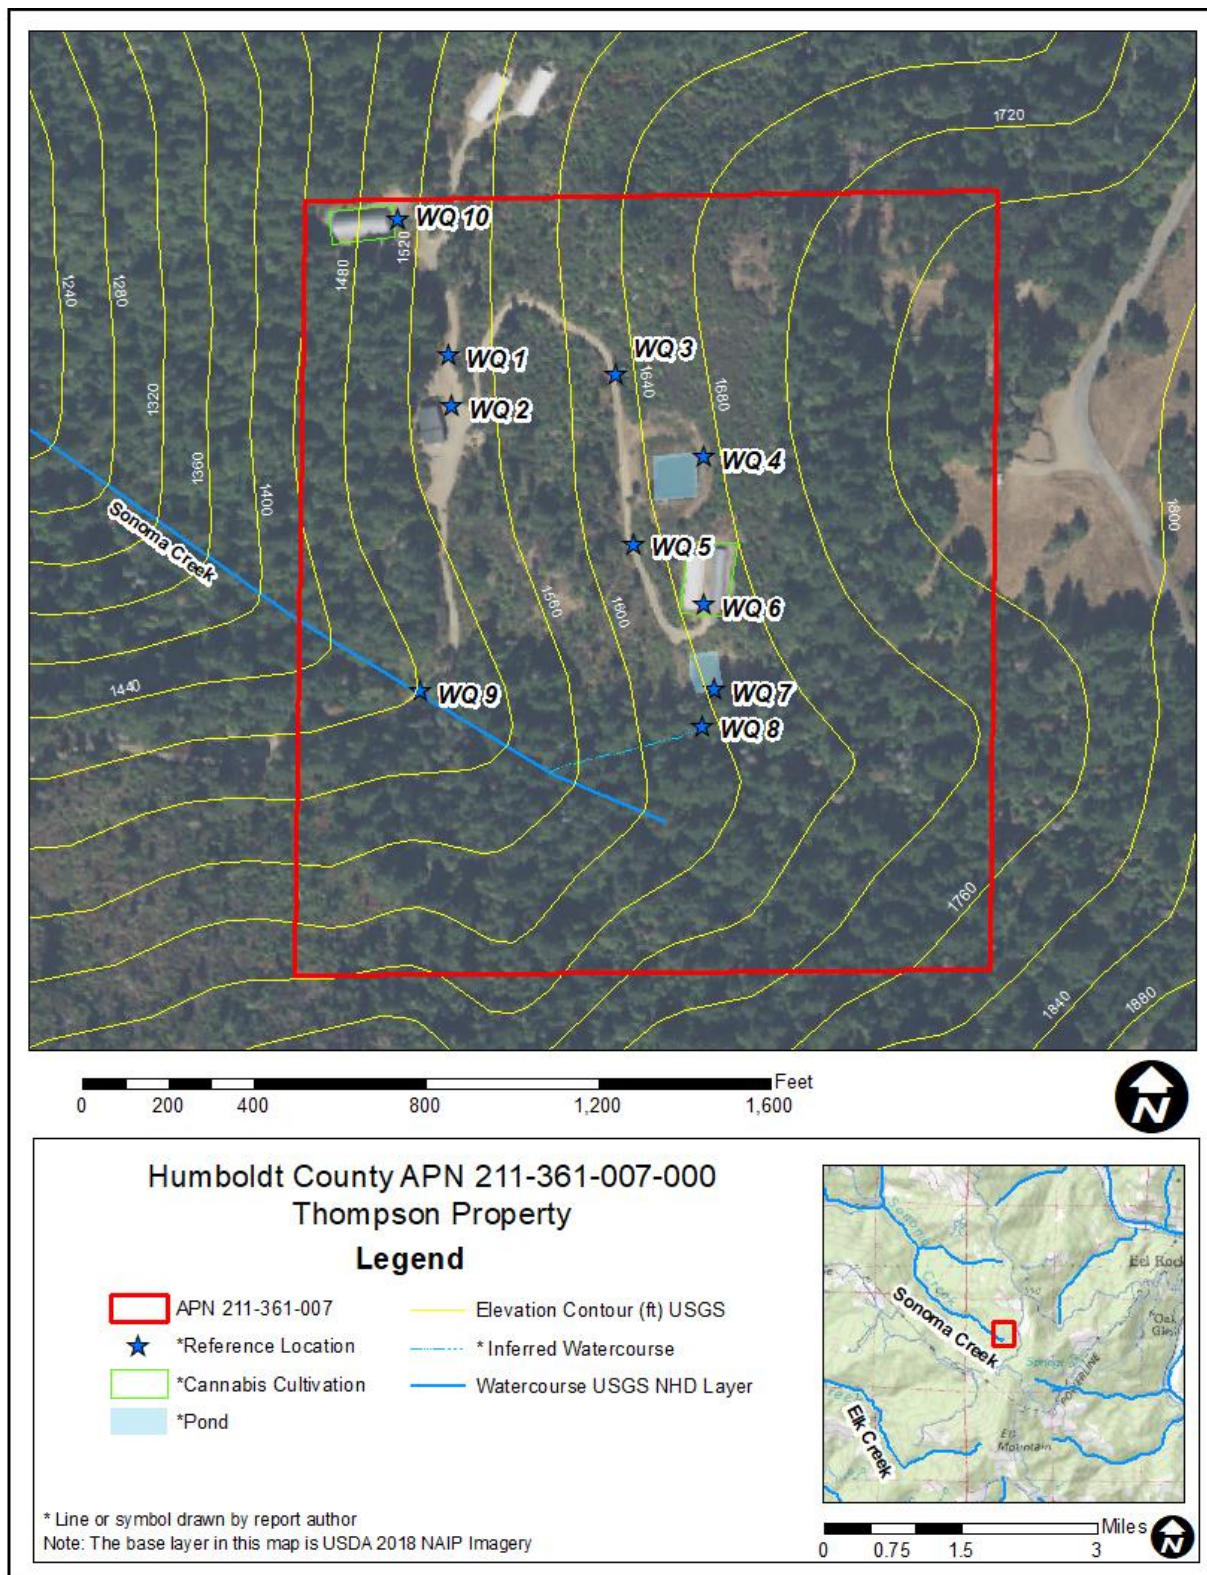
Figure 1: Map of Property, including inspection points of interest.

On September 18, 2019, I inspected the above-referenced property. Figure 1, above, shows inspection points discussed below. I accessed the property from the west and parked at WQ 1. It was raining lightly and I observed stormwater entering the road from the east (Photo 1) and flowing over the edge of the road to the west (Photo 2). I walked south and observed more stormwater flowing from the east at WQ 2 (Photo 3) and past loosely contained refuse to the west (Photo 4). I walked up another road and observed stormwater running off the road in the direction of WQ 1 (Photo 5) and a 350-foot length of hydrologically-connected road upstream from this location to WQ 3 (Photo 6).
